Case Studies

Corrosion of a Stainless Steel Water Filter After Welding

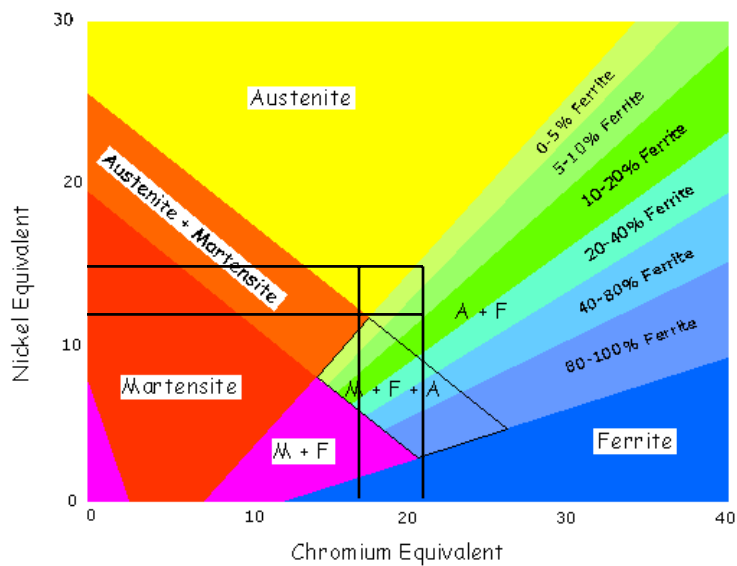
Shaeffler diagram

Depending on precise composition
304 could be unstable at room
Temperature

Cold work could trigger a displacive
Transformation where some of the
austenite forms martensite
