# Case Studies in Steel

## Welding

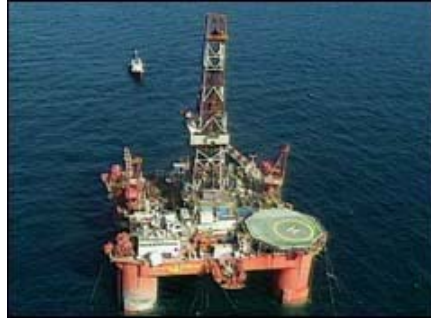
- Situated 235 miles east of Dundee, Scotland in the North Sea
- Owned by Phillips Petroleum (USA)
- The platform is a semi-submersible that floats on two pontoons with legs supporting the main deck. It houses workers while they carry out jobs on the oil rigs (similar to a 5-leg stool)
